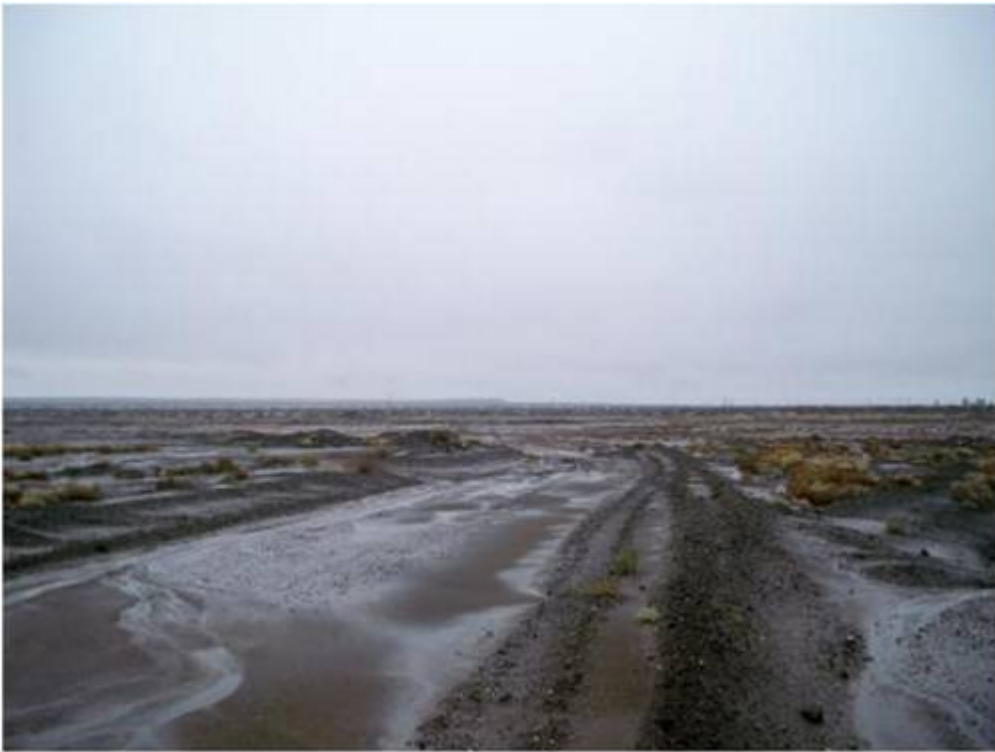
Photo 1: View towards the north indicating the disturbance present on site.

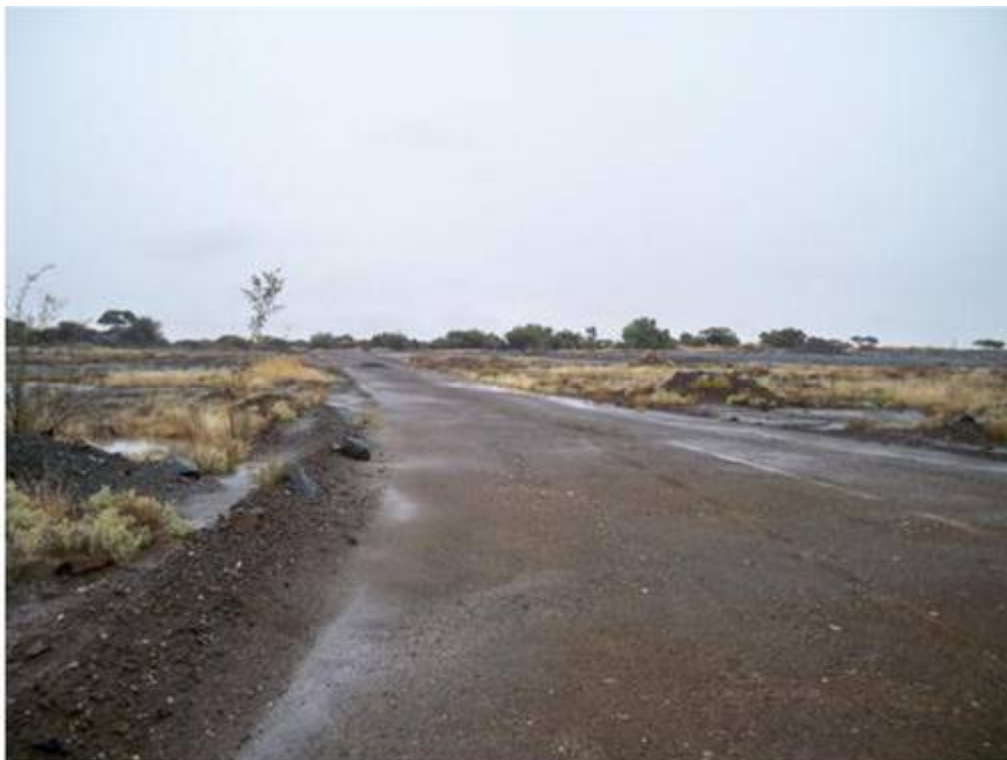
Photo 2: View towards the south indicating one of existing access roads on site.

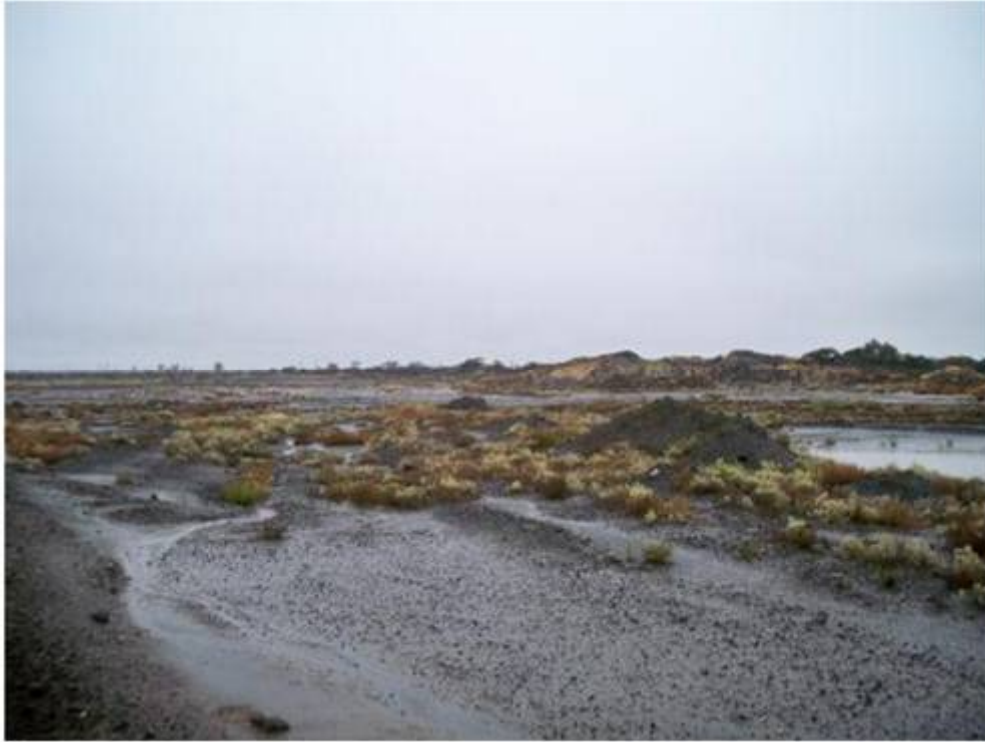
Photo 3: View towards the east with stockpiles visible in background.

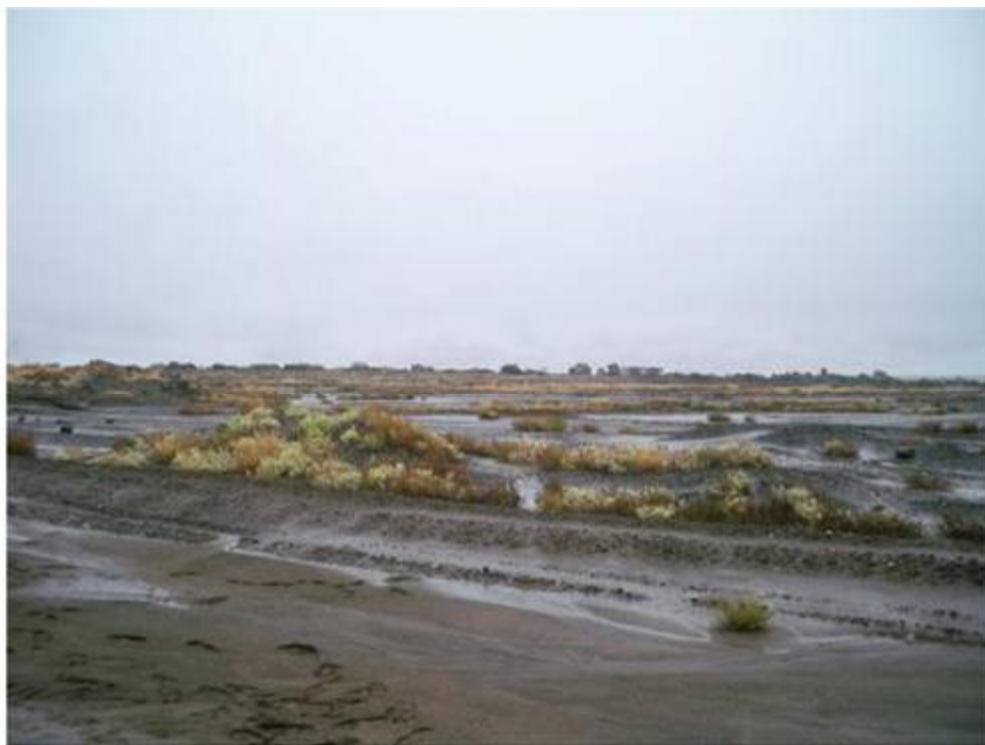
Photo 4: View towards the west with signs of disturbance visible

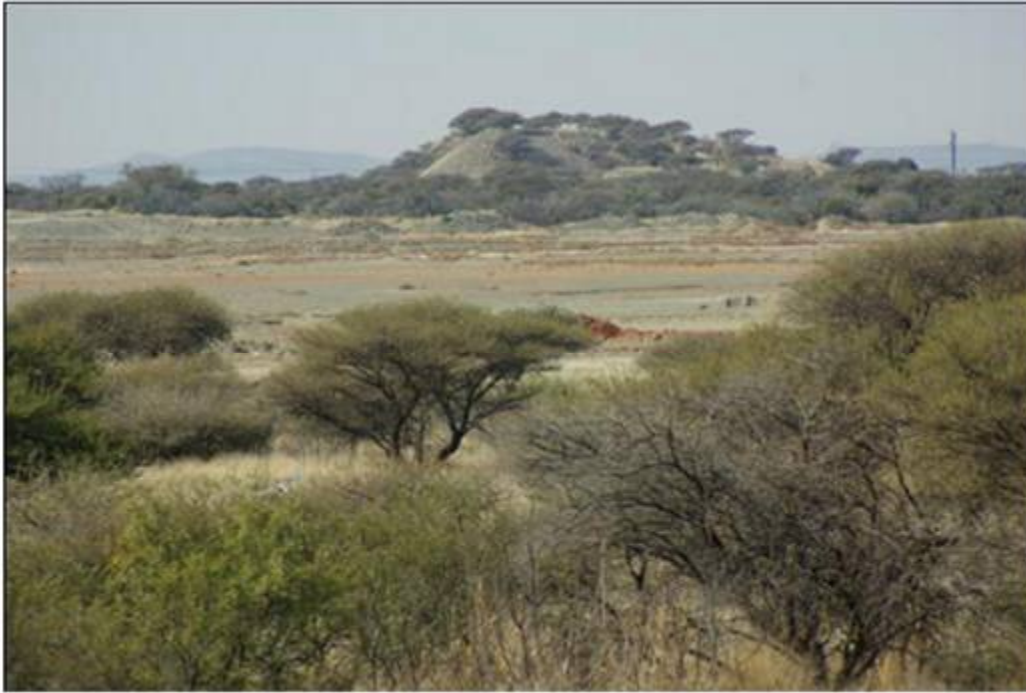
Photo 9: View from the west looking east at the existing tailings dumps on the site

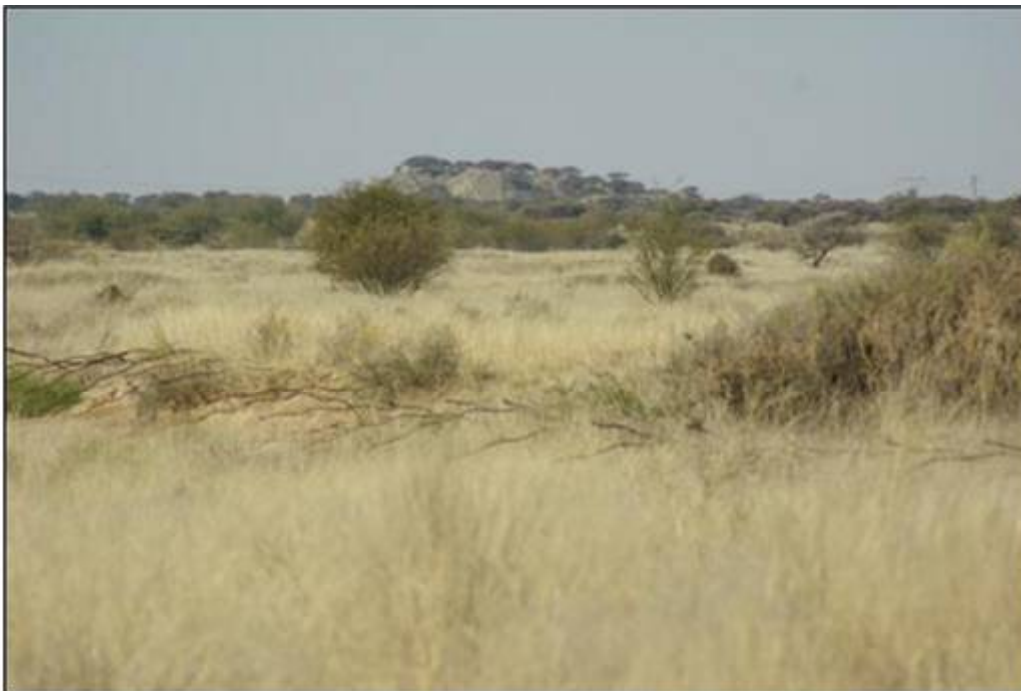
Photo 10: View from the north looking south at the existing tailings dumps on the site
