HERITAGE IMPACT ASSESSMENT FOR THE PROPOSED RHEBOKSFONTEIN WIND ENERGY FACILITY, MALMESBURY MAGISTERIAL DISTRICT, WESTERN CAPE

(Assessment conducted under Section 38 (8) of the
National Heritage Resources Act (No. 25 of 1999) as part of an EIA)

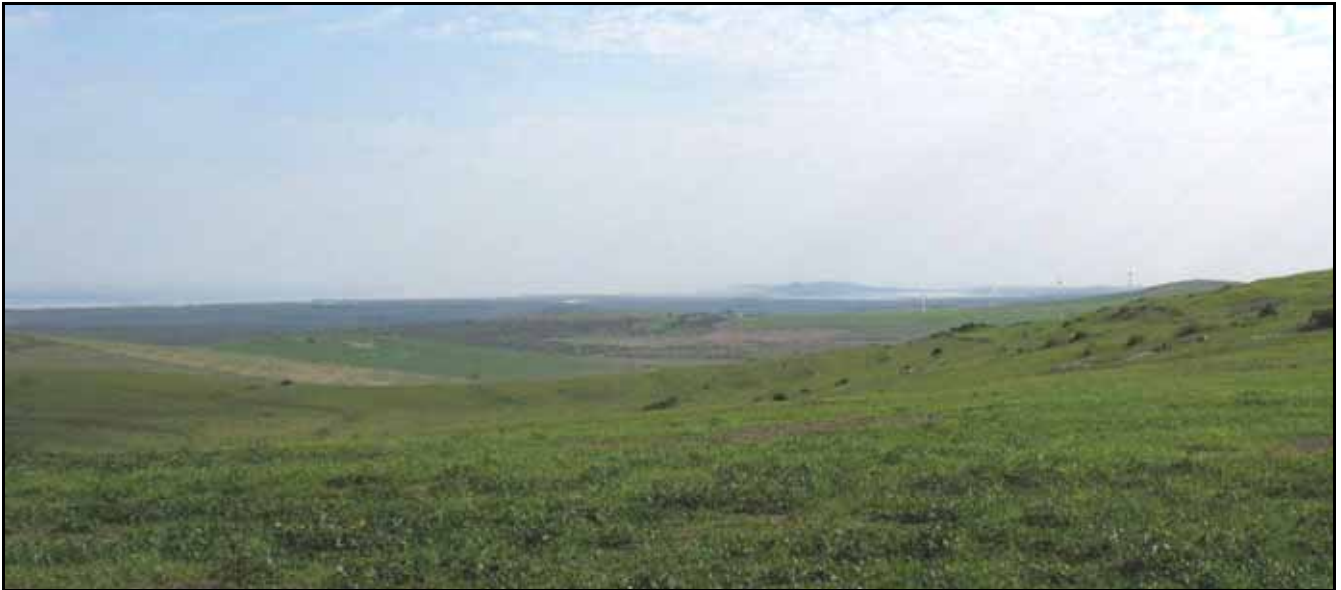
Figure 2: View towards the northwest across the north-western portion of the study area. The existing turbines at the Darling National Demonstration Wind Farm can be seen on the right, while Langebaan Lagoon and the Churchhaven Peninsula are just visible behind them.

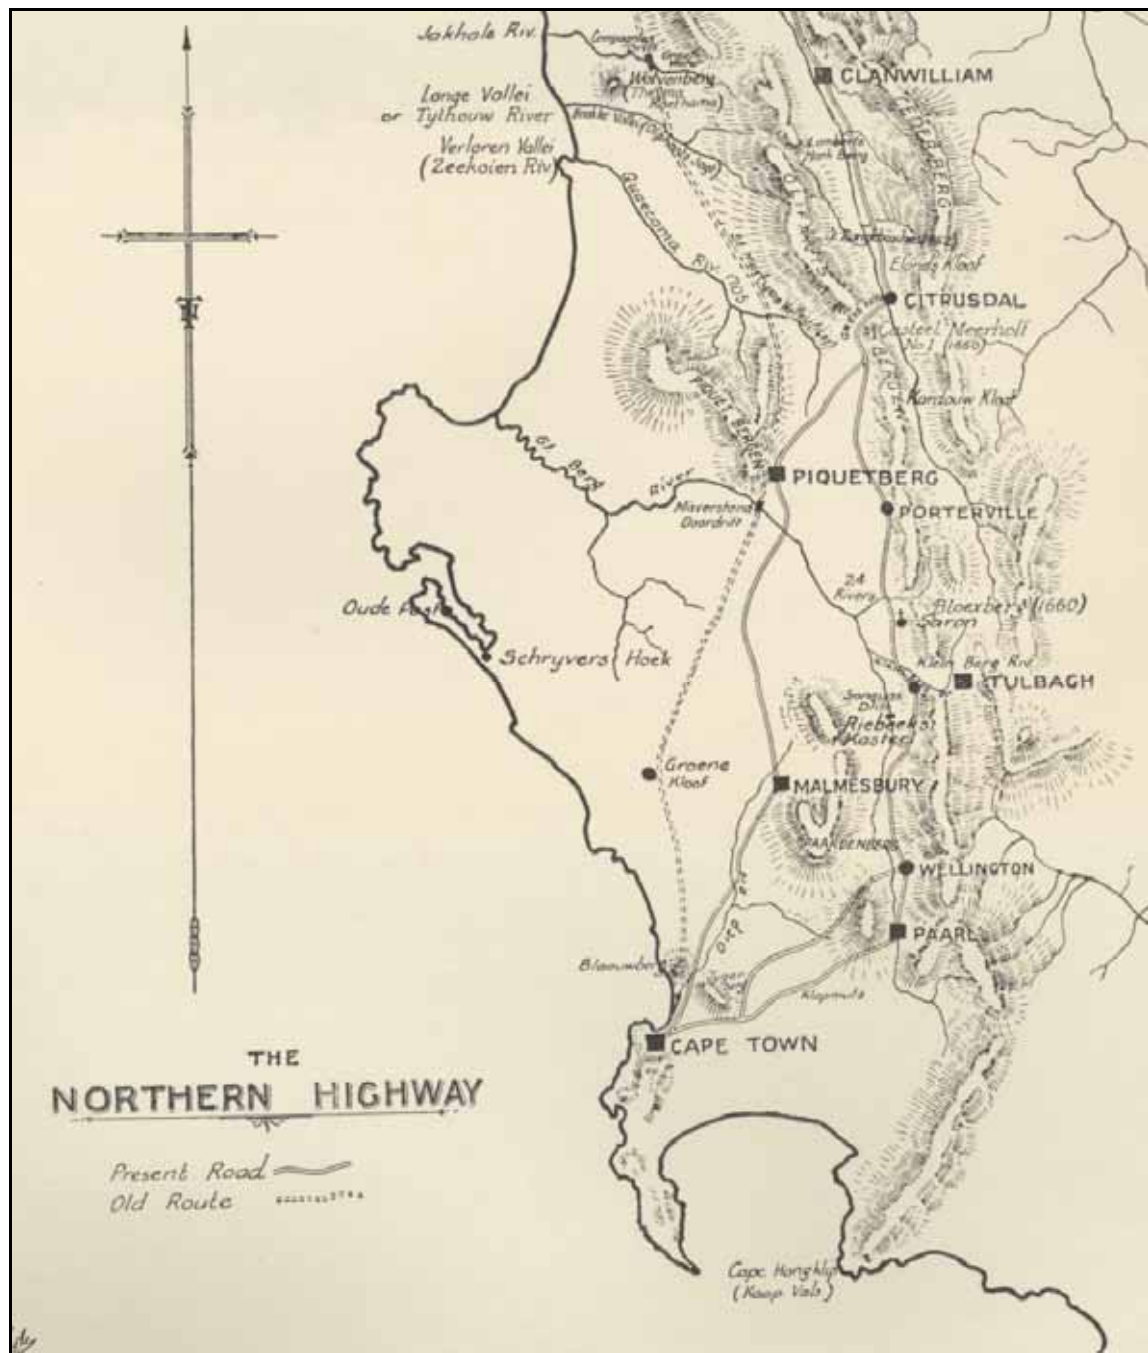
Figure 16: Extract from Mossop's (1927) map showing the main route to the north taken by early travellers. Groene Kloof is the first place marked north of Cape Town.

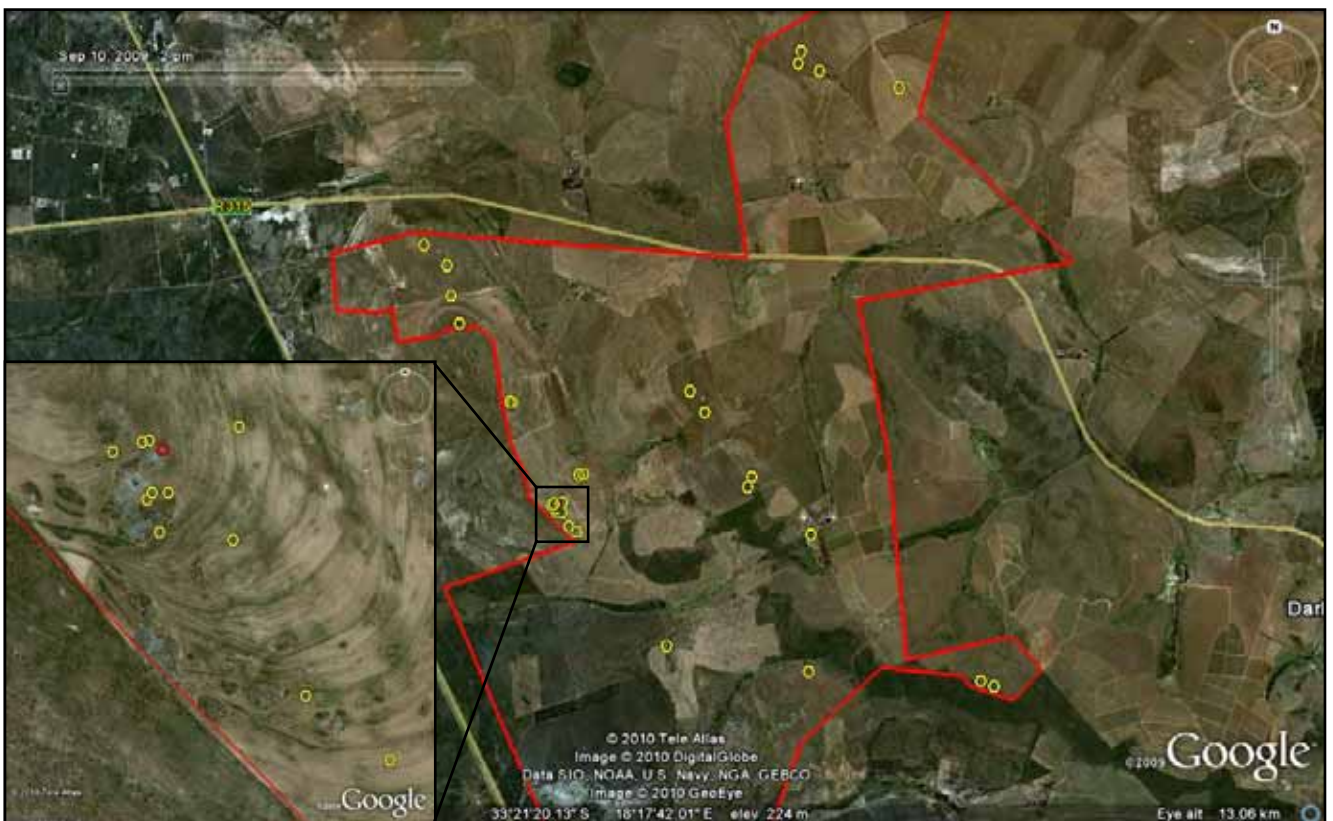
Figure 17: Aerial view of the study area showing the location of all Stone Age artefacts found. The inset shows the vicinity around the Rheboksfontein 1 site. The red circle denotes the site, while all yellow circles are isolated occurrences.

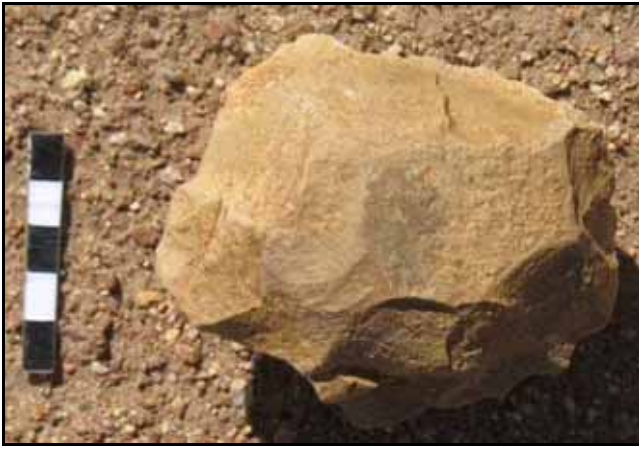
Figure 18: An ESA radial core in silcrete.

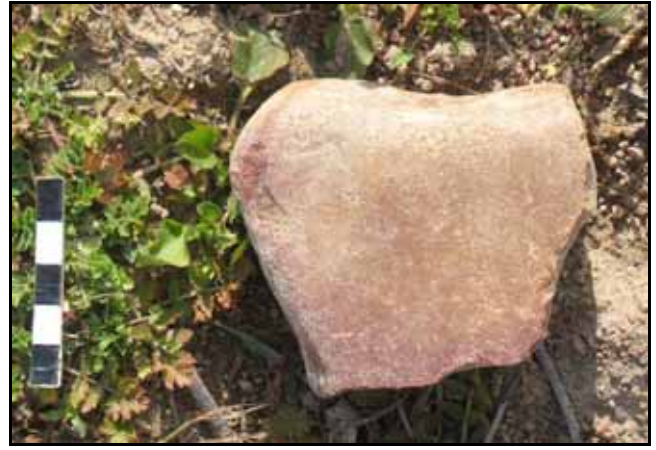
Figure 19: A sandstone lower grindstone fragment found close to Rheboksfontein 1.

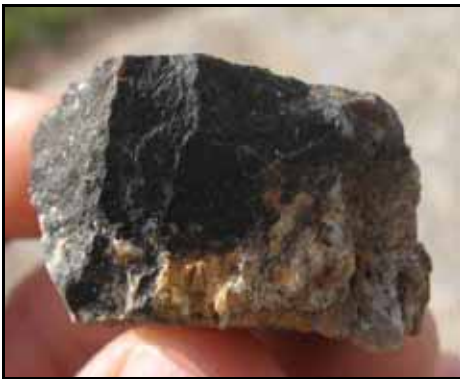
Figure 20: A quartz porphyry single platform core.

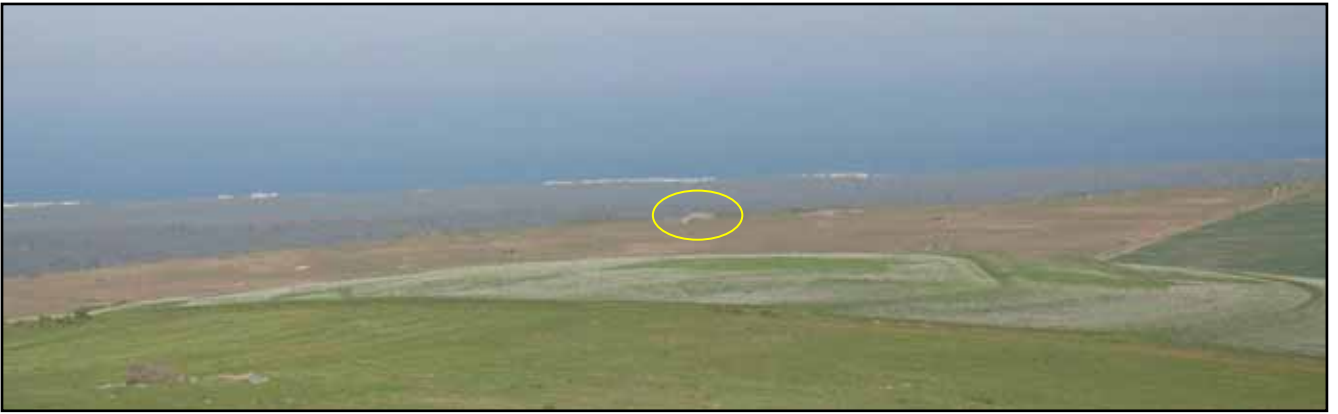
Figure 23: View towards the west showing the position of the Rheboksfontein 1 archaeological site on the ridge overlooking the coastal plain.

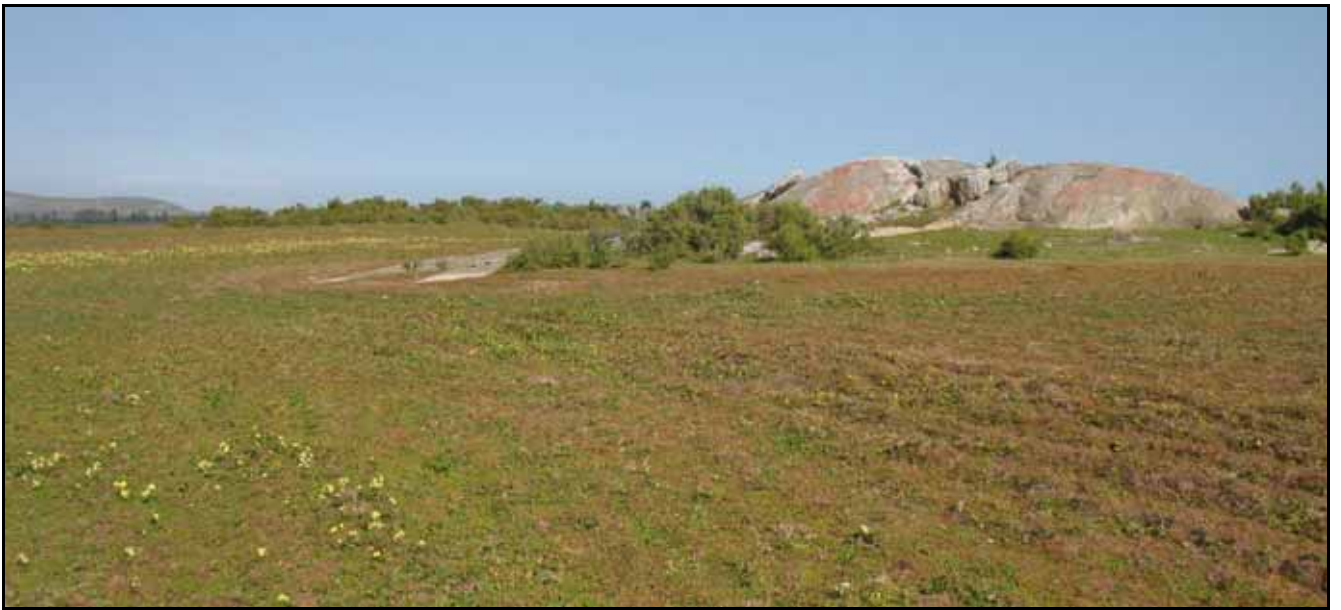
Figure 25: View of Rheboksfontein 1 looking towards the southwest. The highest concentration of artefacts was found in the centre of this view, near the bushes.

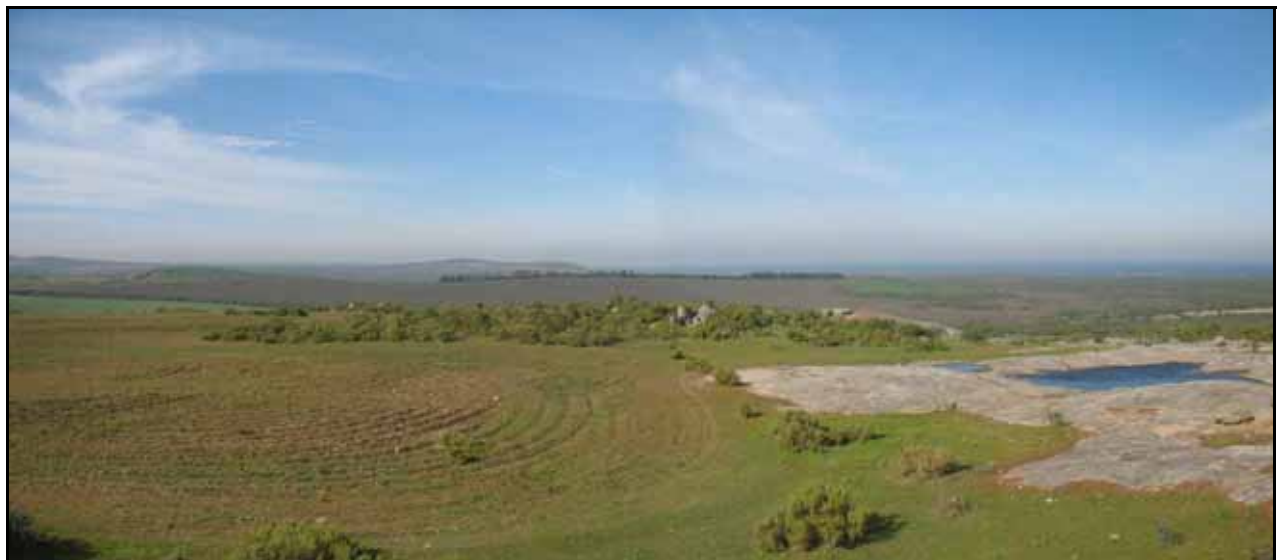
Figure 26: View towards the south from Rheboksfontein 1 showing the hollow filled with rain water.

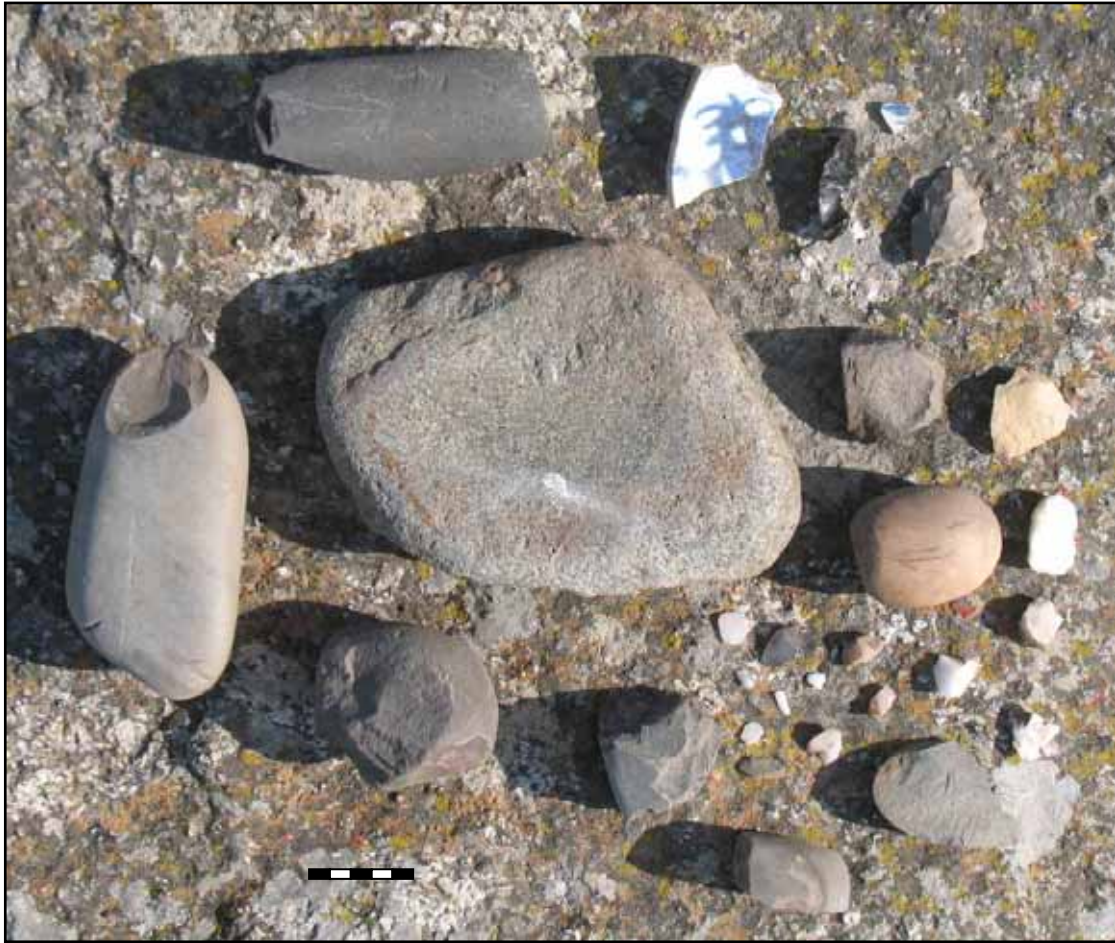
Figure 27: Artefacts found at Rheboksfontein 1. Scale bar in cm.

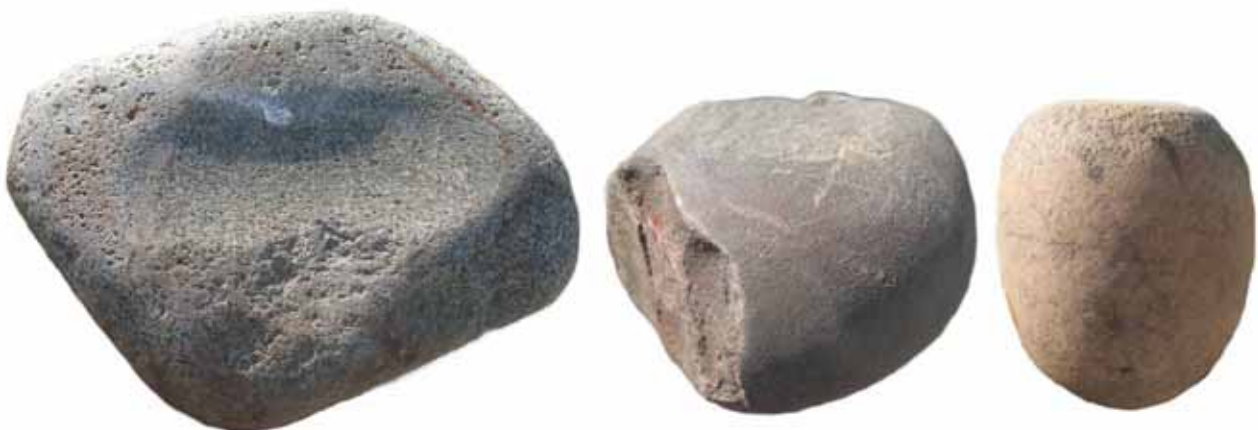
Figure 28: Ground artefacts from Rheboksfontein 1 (not to scale). Left: the grooved lower grindstone; Centre: a grindstone fragment displaying traces of red ochre; Right: a faceted upper grindstone.

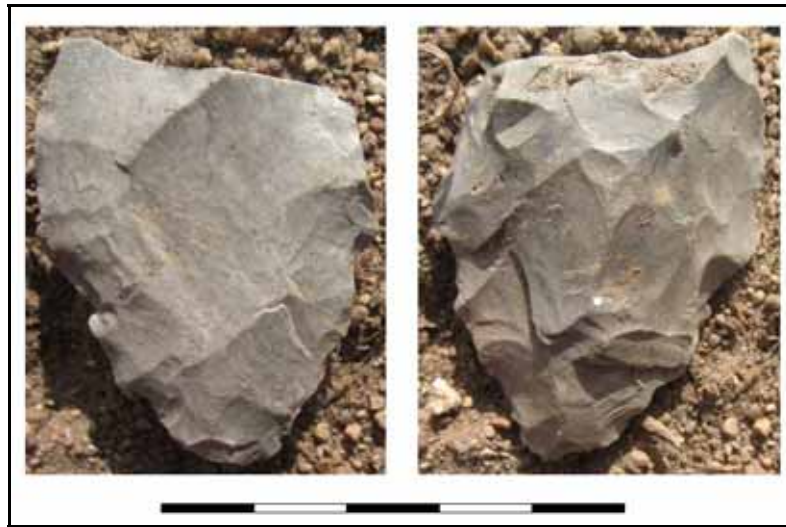
Figure 29: Close up views of both sides of the broken bifacial point from Rheboksfontein 1. Scale in cm.

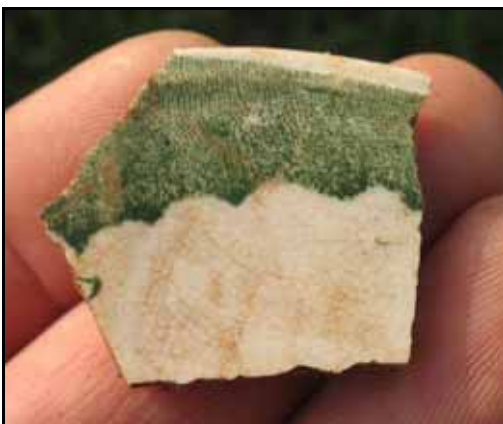
Figure 30: The plate fragment from Wildschutsvlei.

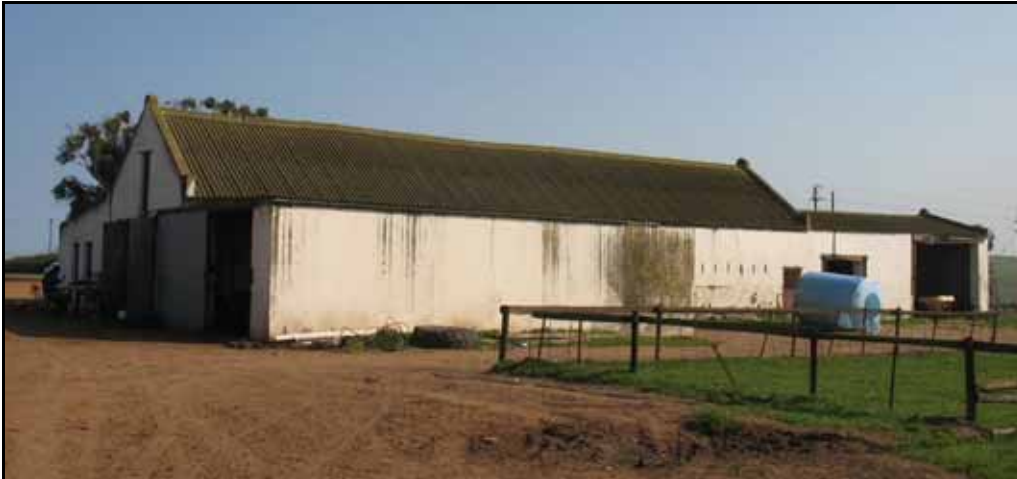
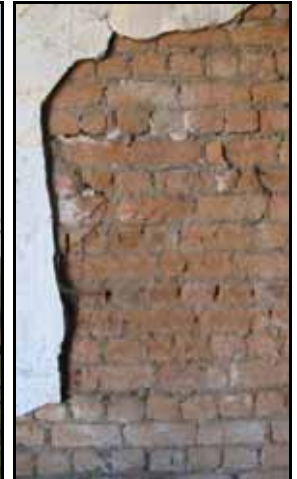
Figure 46: The large barn with its additions.

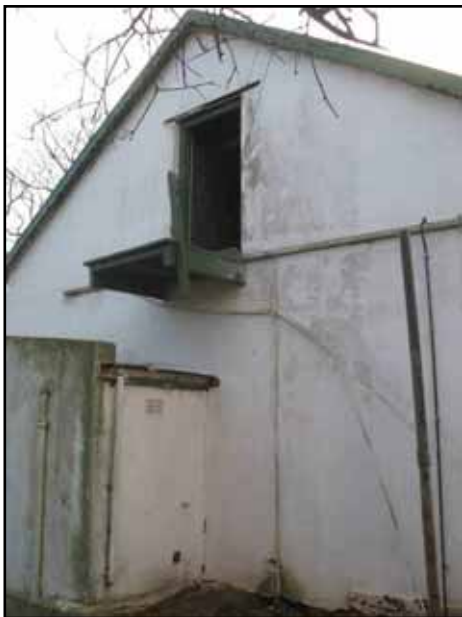
Figure 59: The southern end-gable with the solder staircase missing.

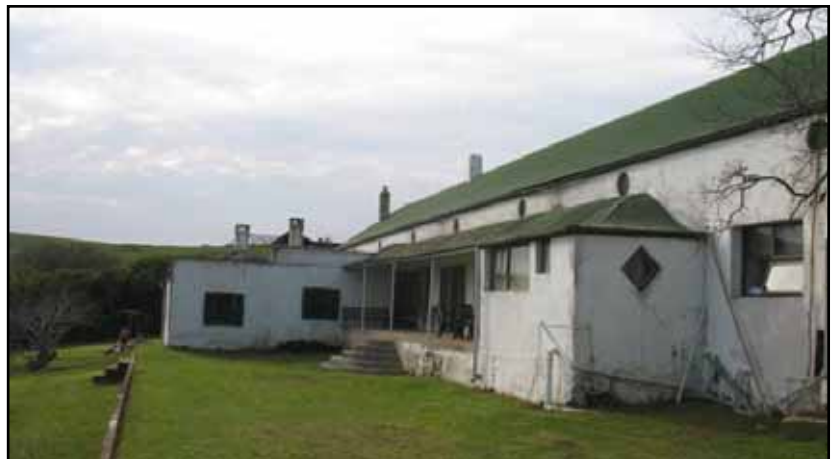
Figure 60: The front, west-facing façade and porch with its curved corrugated iron roof.

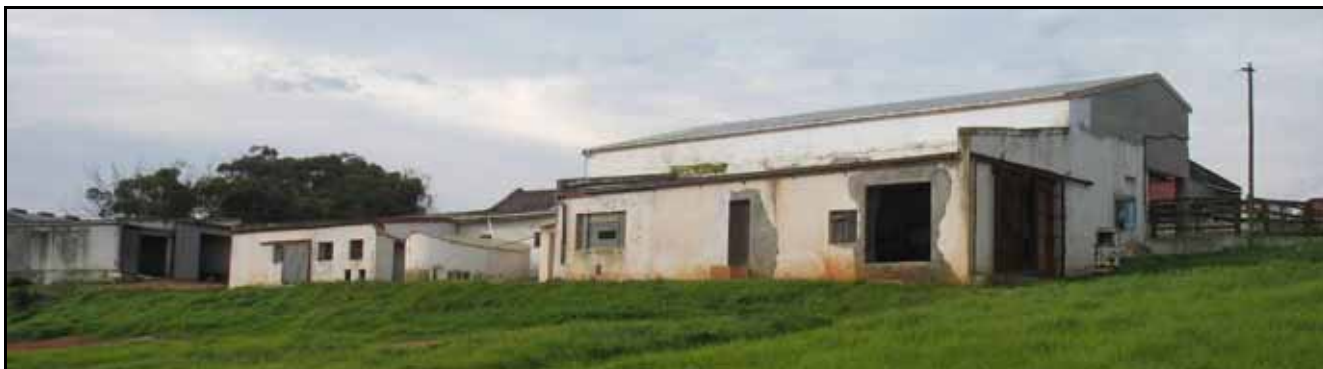
Figure 62: View of the western side of the dairy showing the extensive alterations.

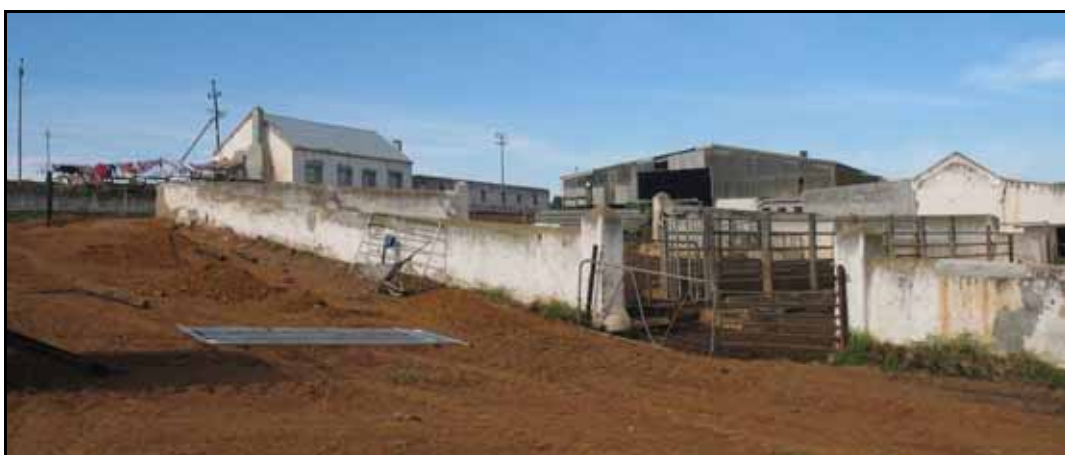
Figure 63: View of the north side of the dairy complex with the associated cottage on the left.

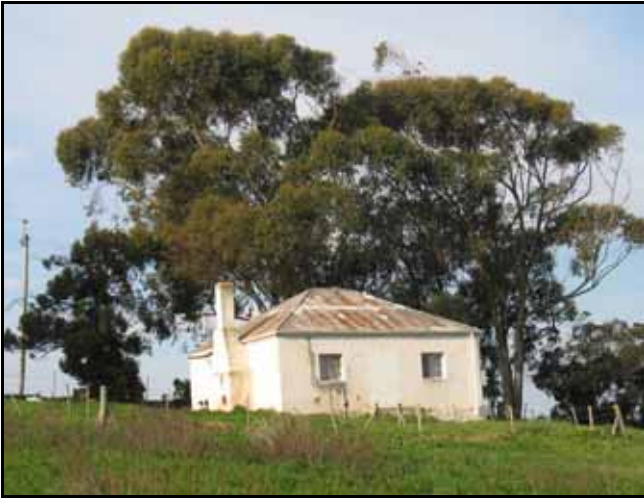
Figure 64: The cottage southeast of the main house.

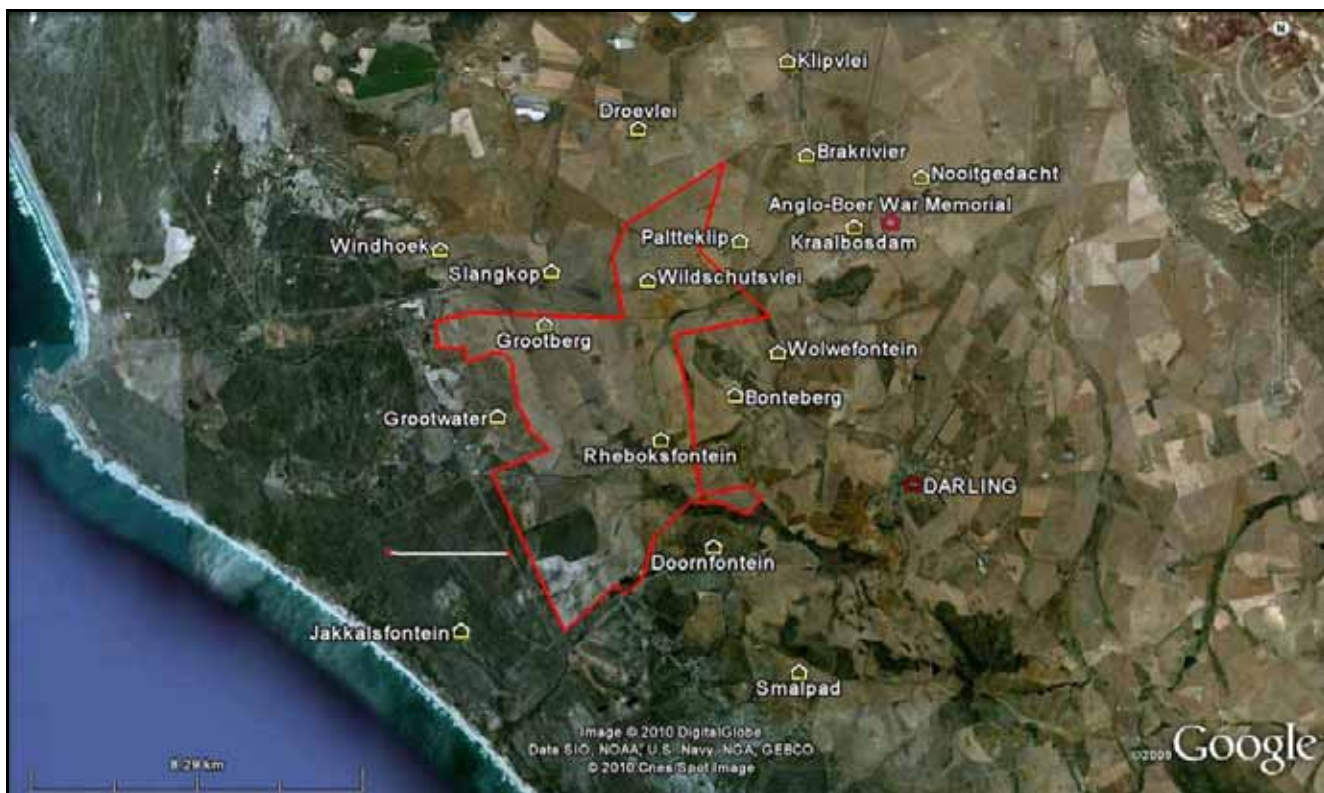
Figure 75: Aerial view of the region showing farm complexes (yellow icons) in close proximity to the study area. The town of Darling and the Anglo-Boer War Memorial (both with red icons) are also indicated. The white scale bar at the lower left corner of the study area represents 3 km.

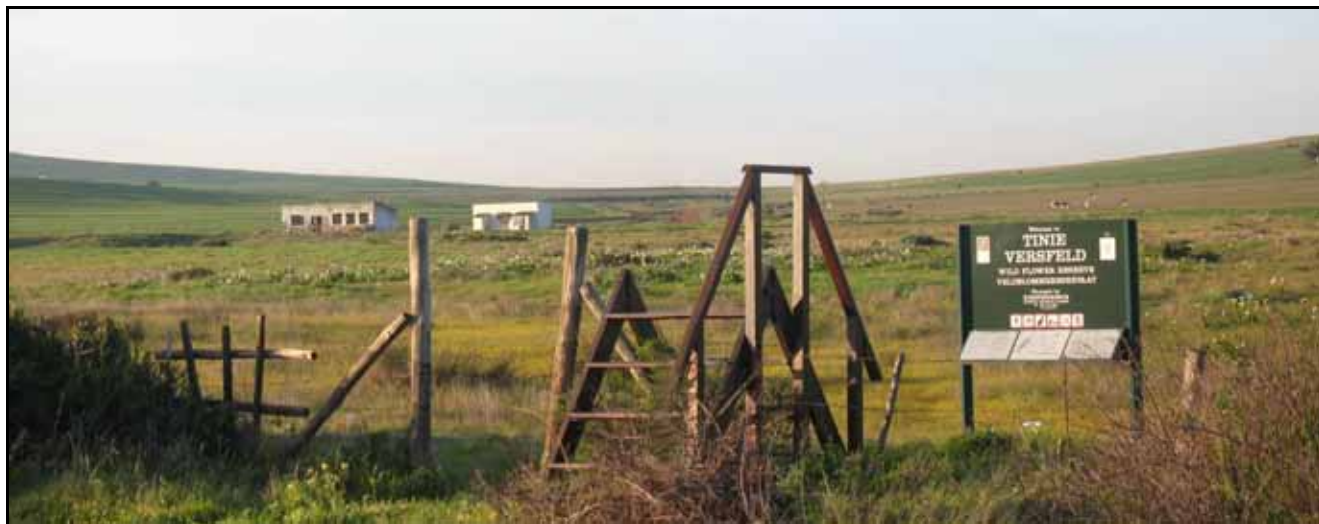
Figure 76: View towards the south from the entrance of the Tienie Versveld Wild Flower Reserve along the R315. The left hand building in the background is the old school which might be reused as part of the WEF.

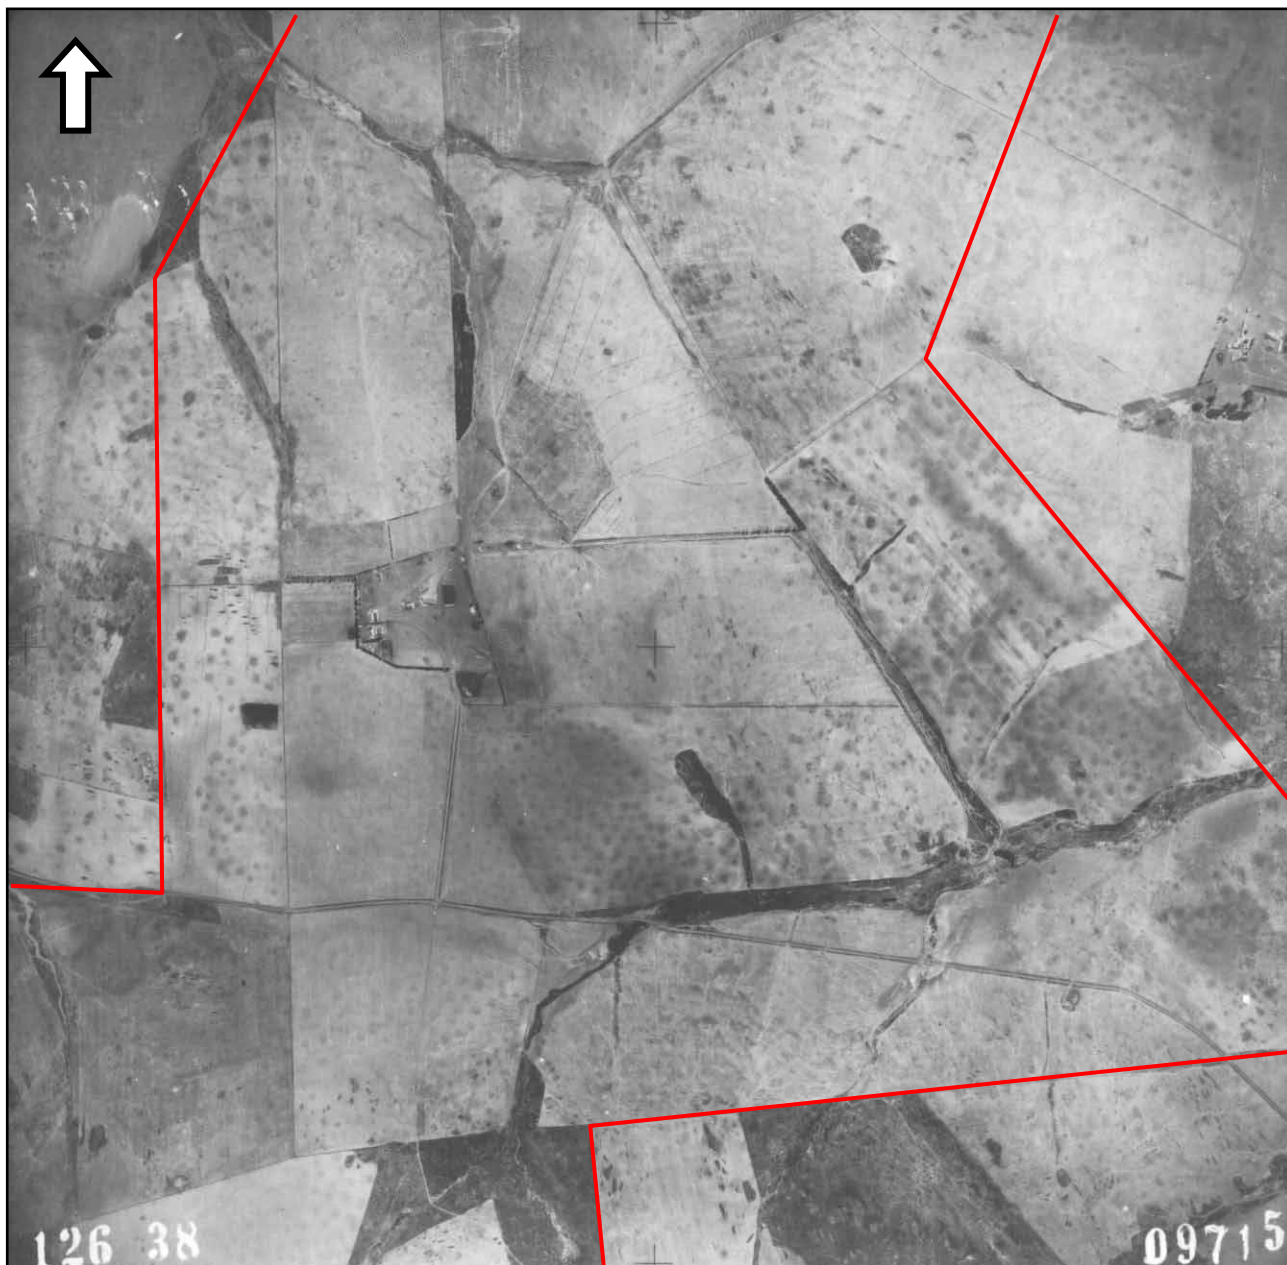
Figure 78: 1938 aerial photograph of the Wildschutsvlei area with the proposed WEF boundaries superimposed in red. The farm complex is visible in the centre. Source: Chief Directorate Surveys and Mapping.

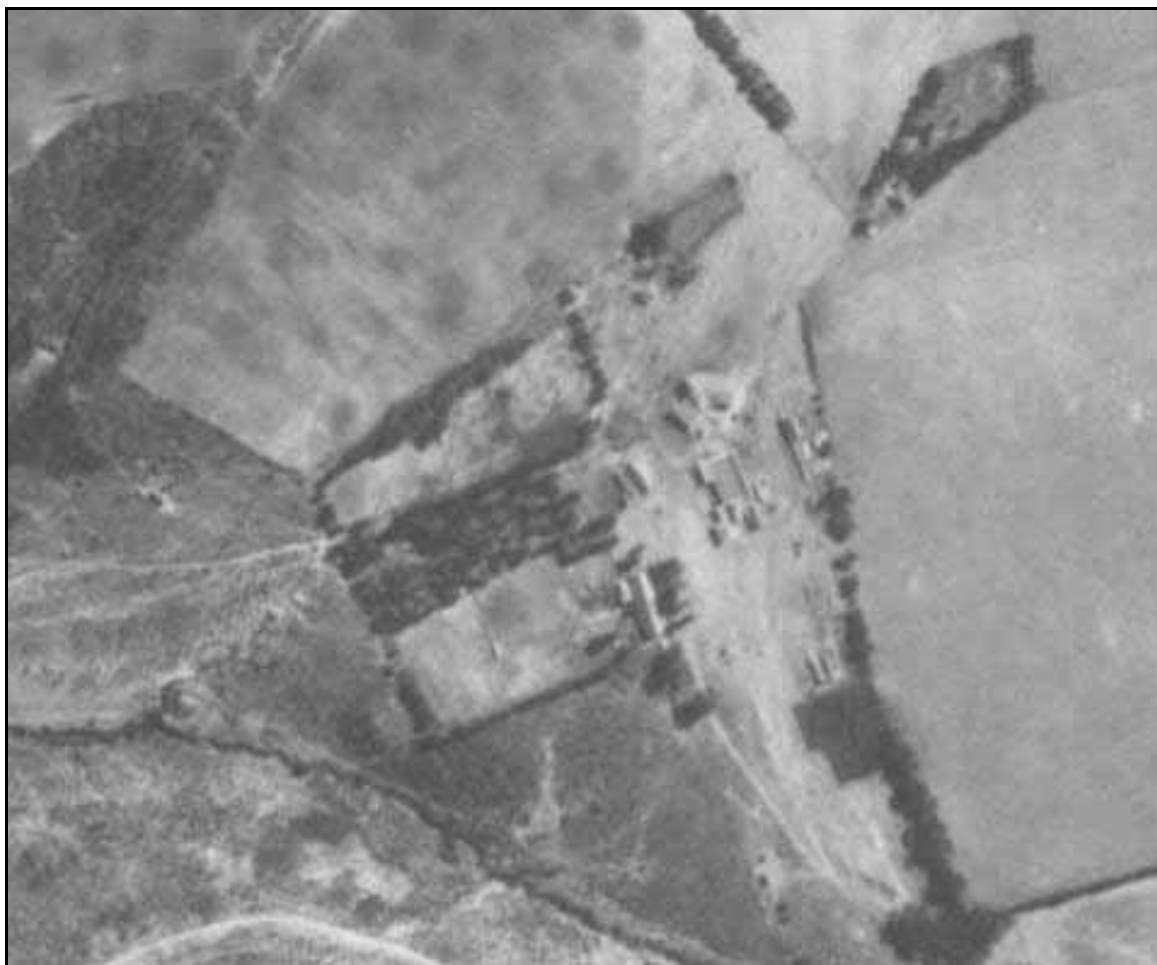
Figure 81: Enlargement of the Rheboksfontein farm complex. Source: Chief Directorate Surveys and Mapping.

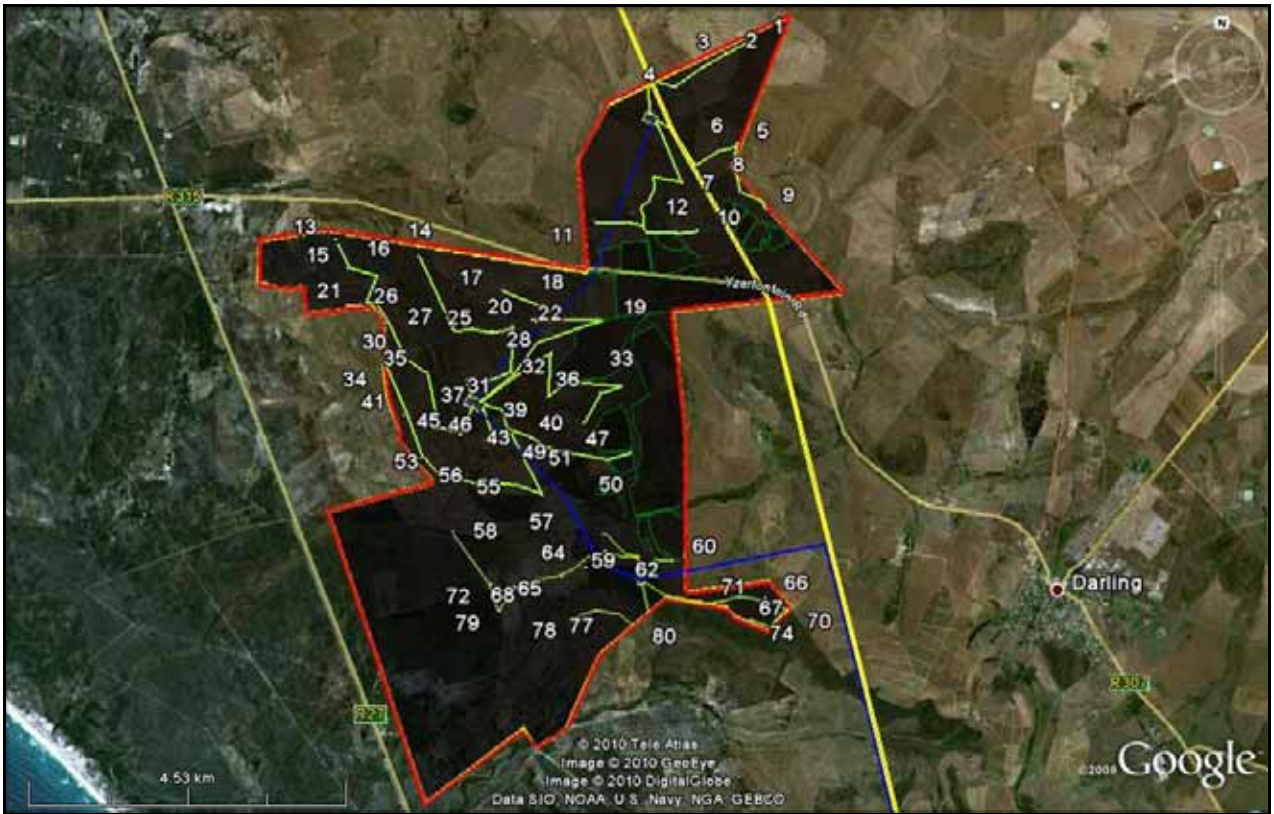
Figure 82: Aerial view of the proposed WEF area showing the overhead power line in dark blue. The yellow line running north-south is an existing power line whose course would be followed up to the Dassenburg substation.
