**ASSESSMENT OF THE IMPACT THAT THE  
REMEDICATION OF ASBESTOS CONTAMINATED  
SOIL MAY HAVE ON THE SOIL ENVIRONMENT:  
POLOKWANE AND APIESDORING YARDS  
(LIMPOPO PROVINCE)**

15 September 2011

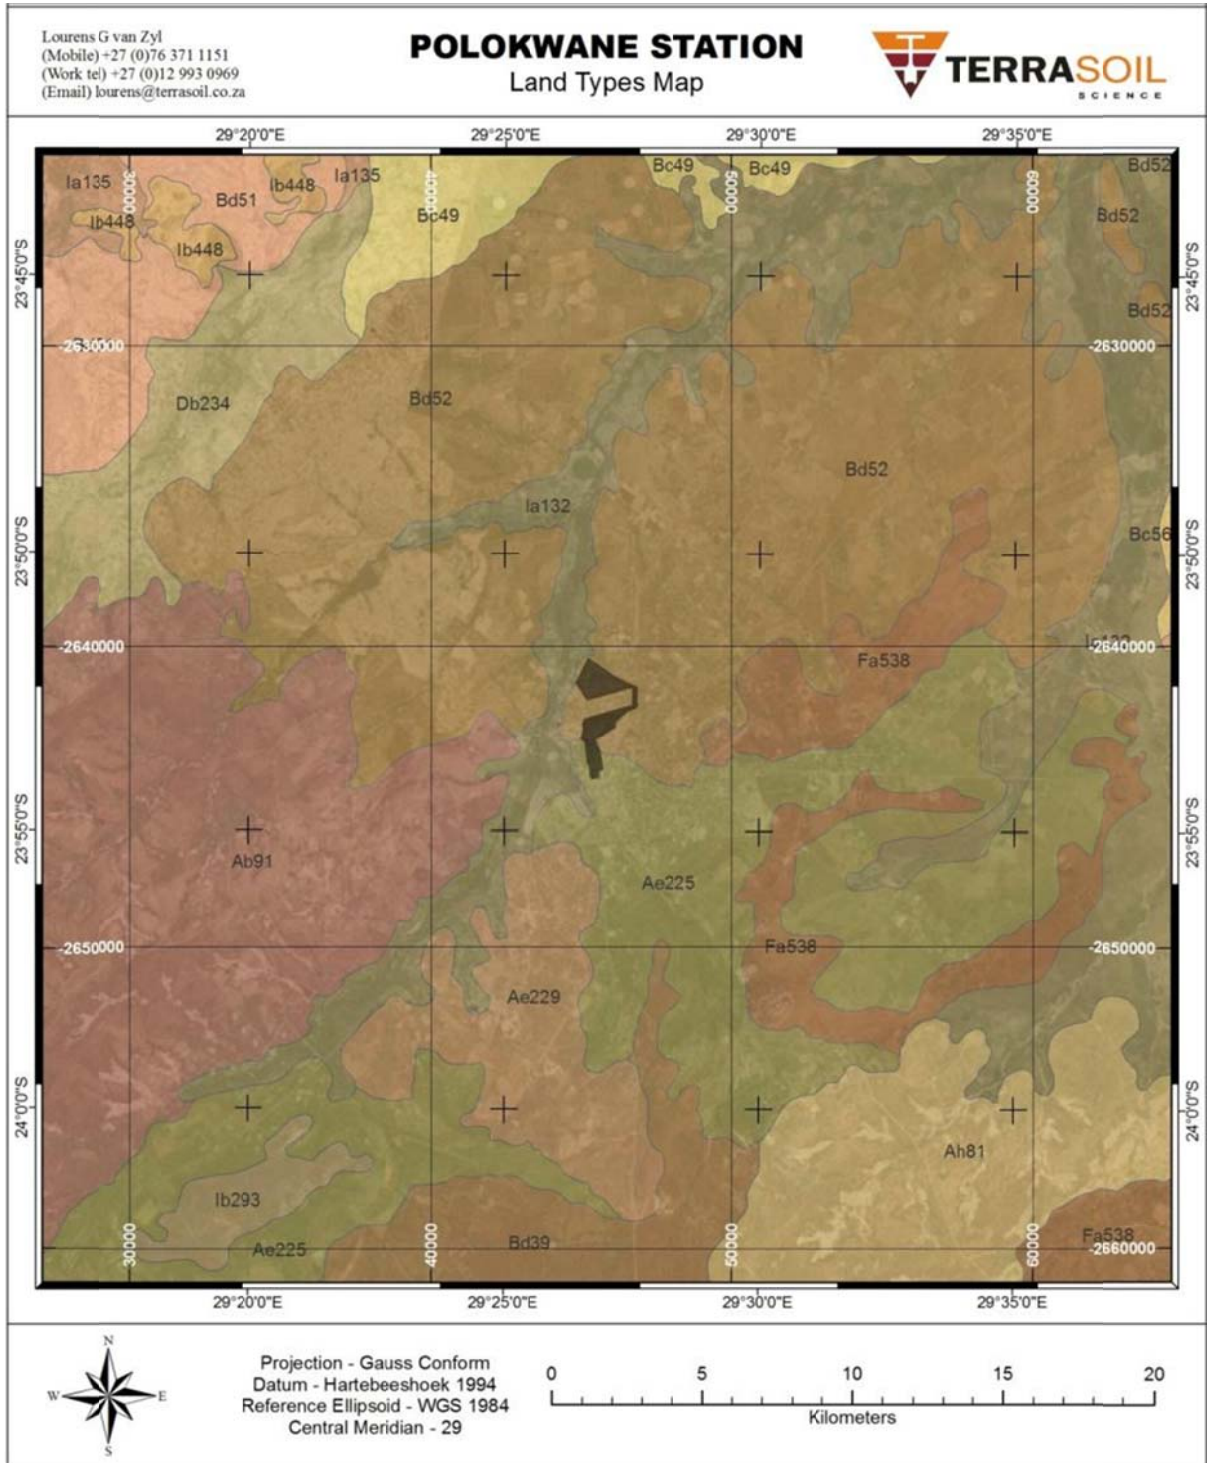
**Figure 2** Land type data for the Polokwane yard

Figure 2 and Figure 3 illustrate the land type data for the study areas. The Polokwane yard is situated in the Ae and Bd land types while the Apiesdoring yard is situated in the Ae land type. The Ae land type is described as “red-yellow apedal, freely drained soils” and refers to yellow and red coloured soils where a free water table are not encountered. The Bd land type is described as a “plinthic catena: upland duplex and marginalitic soils rare.” A perfect catena is represented by (from higher to lower lying areas) Hutton, Bainsvlei, Avalon and Longlands soil forms. Gleyed soils, such as Rensburg, Willowbrook, Katspruit and Champagne soil forms, can occur in the valley bottom. Soils with hard plinthite are common in areas where sandstone underlies the area. Where water tables have not extended far beyond the valley bottom, red soils may dominate. In these cases plinthic soils are restricted to valley bottoms and pans.

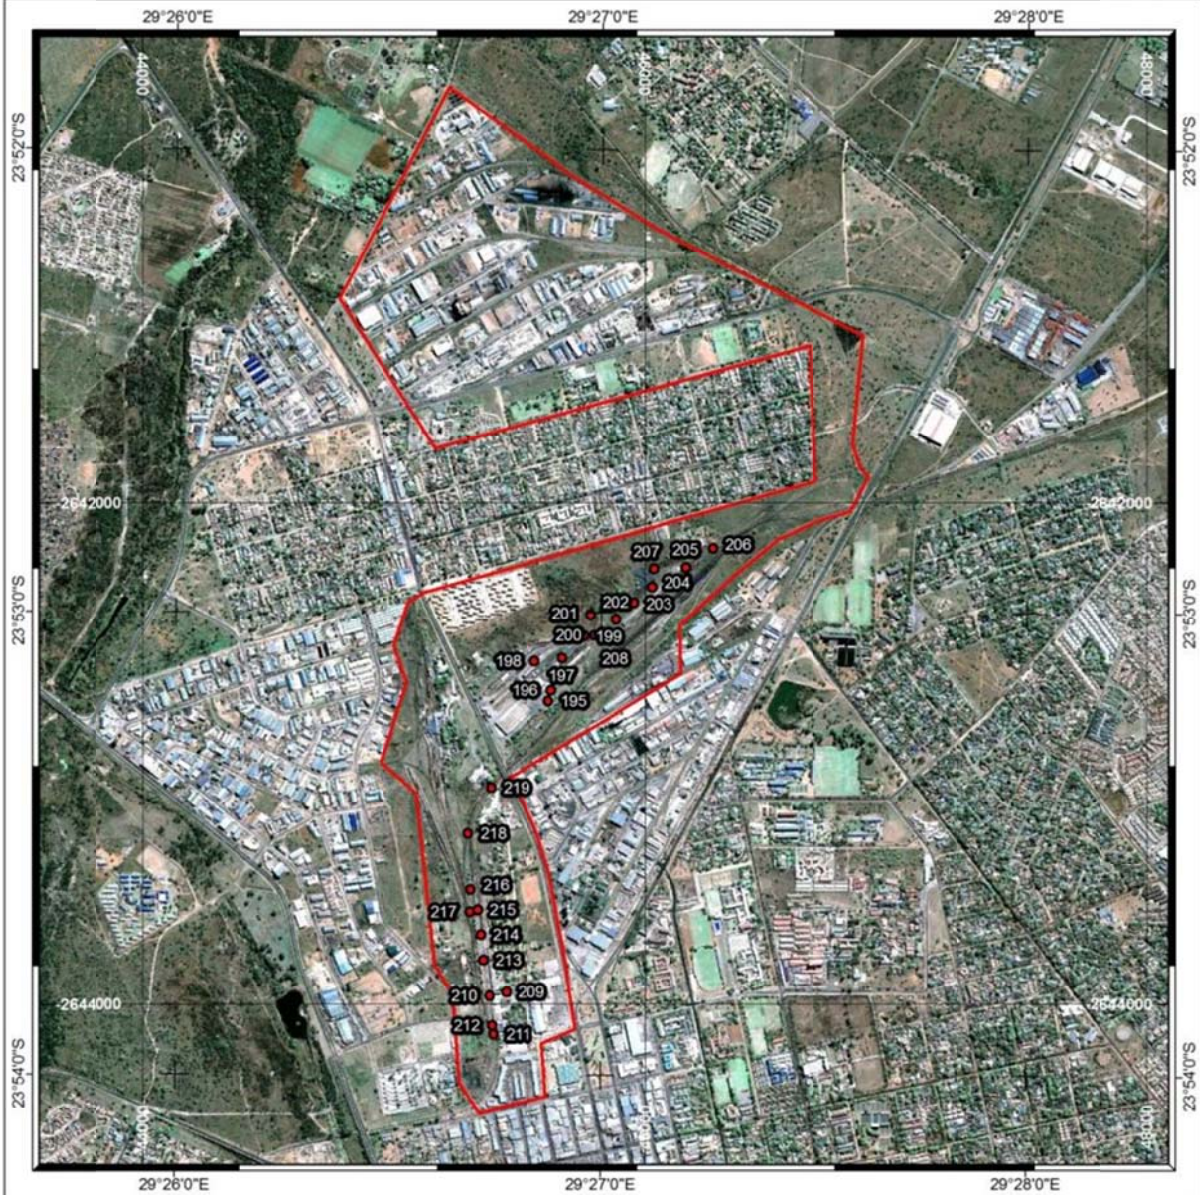
**Figure 5** Observation points map for the Polokwane yard

Figure 5 and Figure 6 illustrate the observation points for the Polokwane and Apiesdoring yards, respectively. The Polokwane yard falls within urban development. The area itself has been transformed to such an extent that natural occurring soils were only noted at points 205 and 206. These soils are of the Hutton soil form. Figure 7 illustrate the apedal structure of the soil form. Figure 8 and 9 illustrate the extent of transformation.

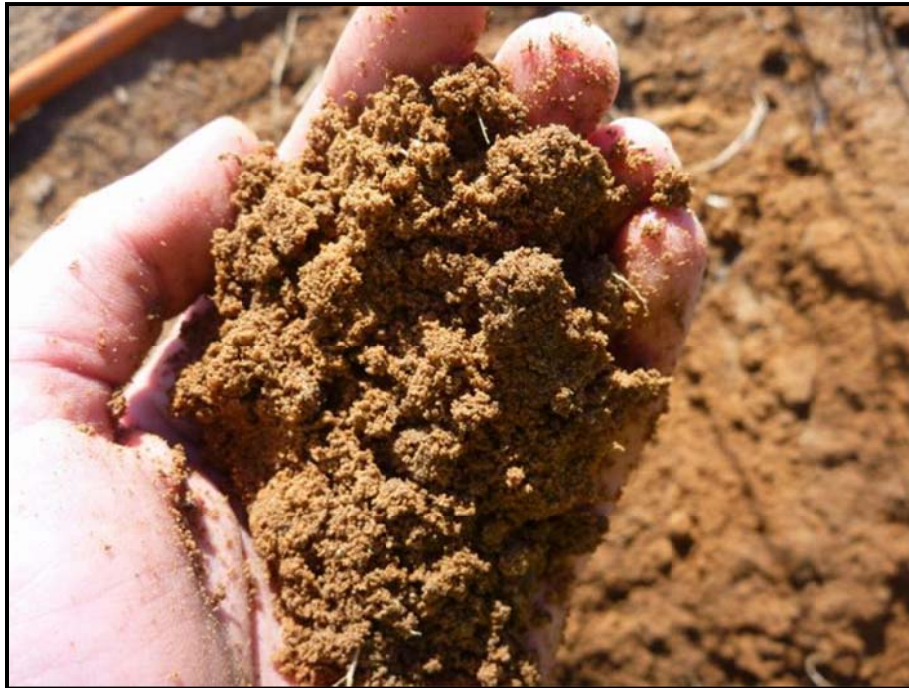
- The Hutton soil form comprises an orthic A-horizon overlying a red apedal B-horizon, underlain by unspecified material. The yellow-brown apedal B-horizon has macroscopically weakly developed structure or is altogether without structure and reflects weathering under well drained, oxidised conditions. The clay fraction is dominated by non-swelling 1:1 clay minerals and the red colour of the soil is

**Figure 7** The Hutton soil form exhibits an apedal structure

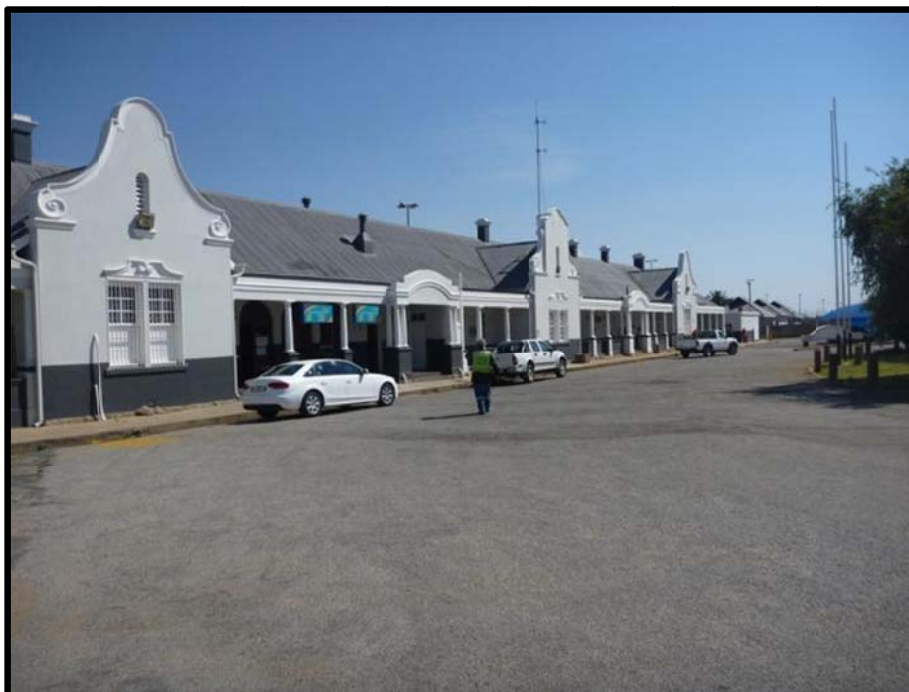
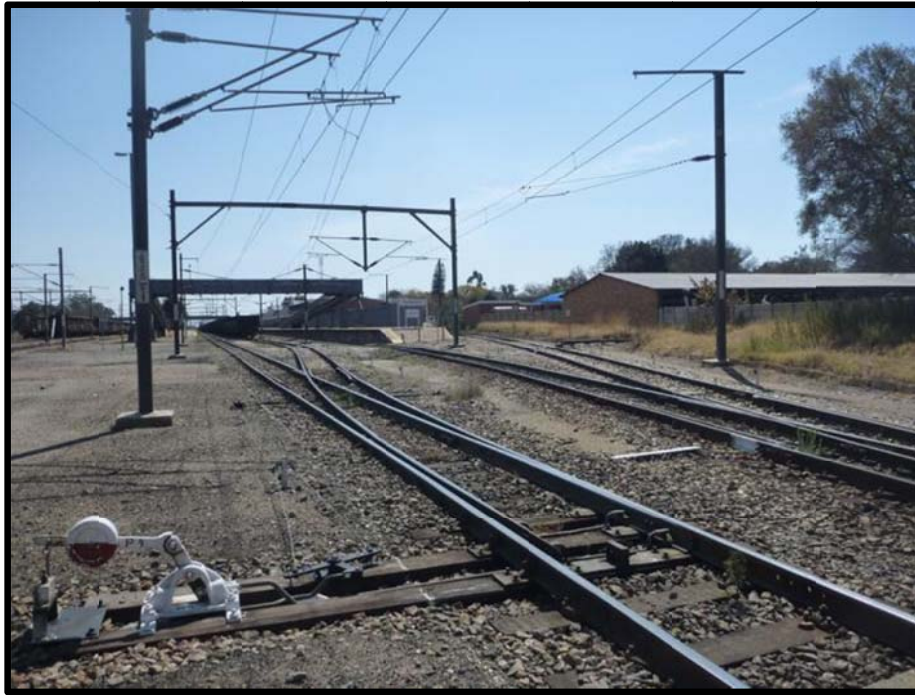
**Figure 8** Photo illustrating the transformation of the natural occurring soils owing to development

**Figure 9** Photo illustrating the transformation of the natural occurring soils owing to development

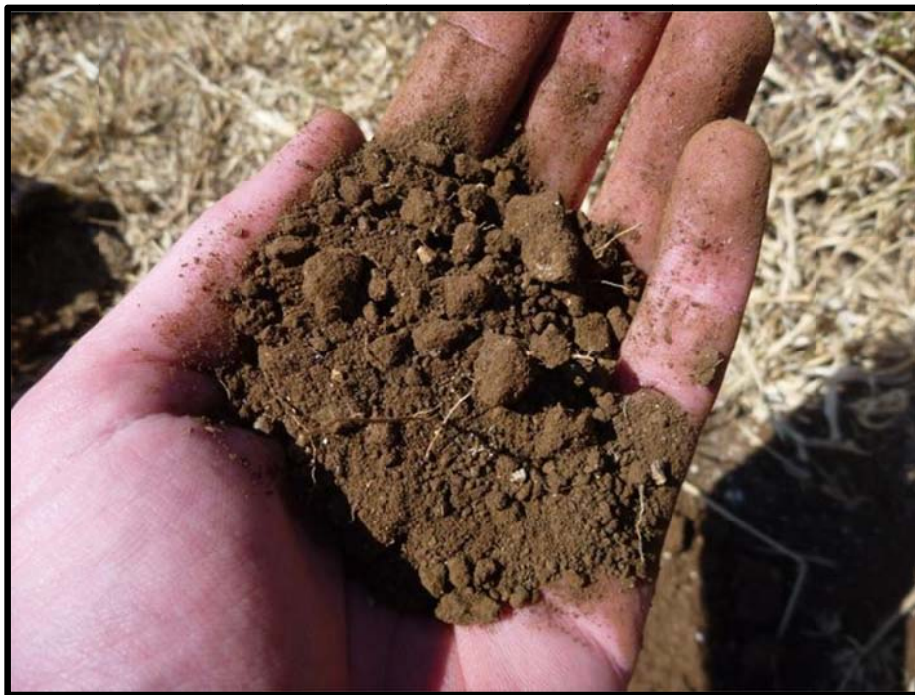
- The Oakleaf soil form comprises an orthic A-horizon that overlies a neocutanic B-horizon and unspecified material. The neocutanic B-horizon is characterised by colour variation due to clay movement and accumulation and an apedal or weakly developed structure.
- The Mispah soil form comprises an orthic A-horizon that overlies hard rock.
- The Glenrosa soil form comprises an orthic A-horizon overlying a lithocutanic B-horizon. The lithocutanic B-horizon is a pedologically young horizon where clay illuviation has occurred.

The soils found in the Apiesdoring yard have also been transformed and the only natural soils are found outside the yard. Point 187 is an observation made outside the yard and constitutes the Oakleaf soil form as illustrated by Figure 10. Figure 11 and 12 illustrate the transformation of natural occurring soils owing to discard of waste and development of infrastructure related to railway yards.

**Figure 10** The neocutanic B-horizon of the Oakleaf soil form exhibits a variation in colour owing to clay movement

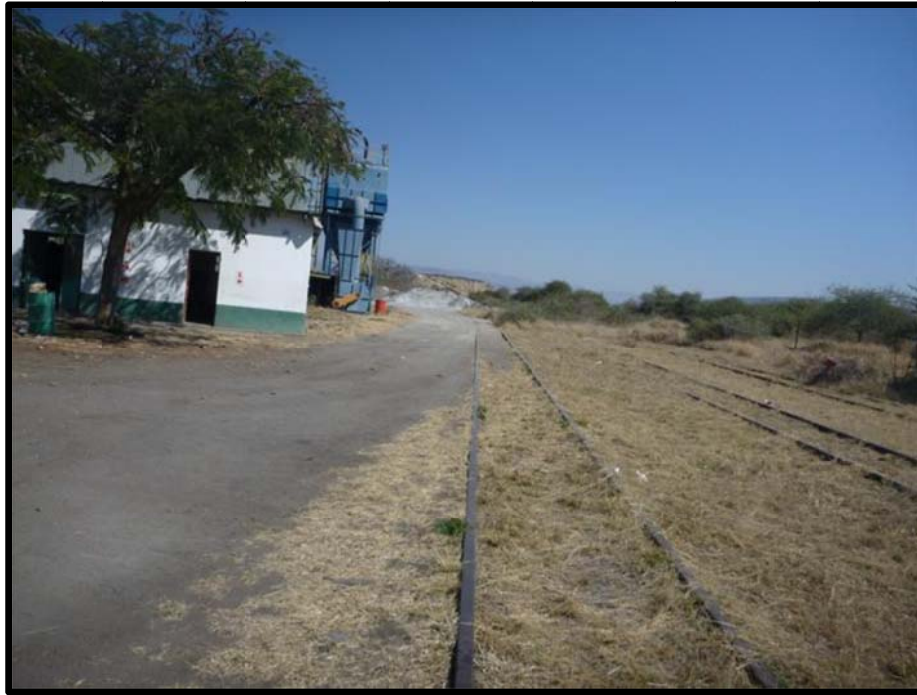
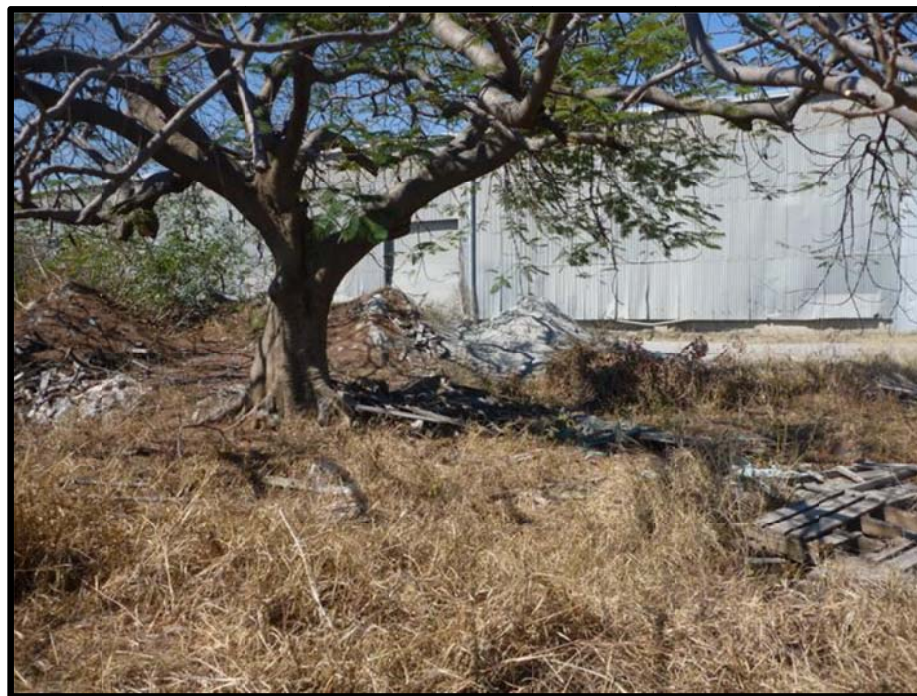
**Figure 11** The soils of the Apiesdoring yard have largely been disturbed

**Figure 12** The soils of the Apiesdoring yard have largely been disturbed
